# LCU-ONE

# **ON-TRACK SESSIONS**

Kart: Birel EasyKart 125

Engine: IAME Leopard 125cc

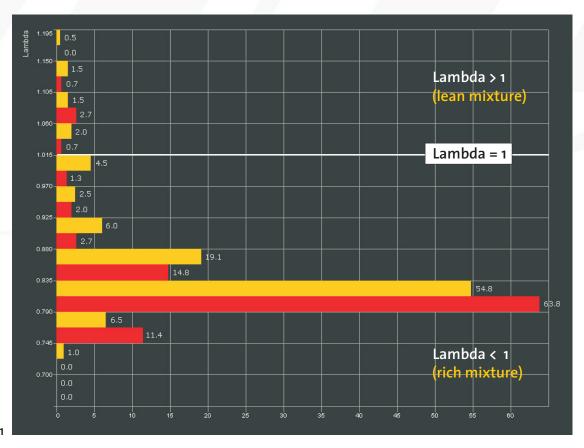
Picture 1

The yellow histogram shows the Lambda value of one of the first laps, while the red histogram one of the latest.

Notice that for Lambda < 0,85 (lower part of the histogram) the red bars have a greater value, which means the engine worked richer for a longer time. The driver should correct carburator calibration by acting on the rpm screws.

As you can notice in the following pictures, the engine started with a carburation that was growing richer in the following 24 laps because of a wrong carburator setting. The carburator lost calibration and pressure.
